LINCOLN ARCHAEOLOGICAL STUDIES No. 4

The Archaeology of the Lower City and Adjacent Suburbs

Kate Steane

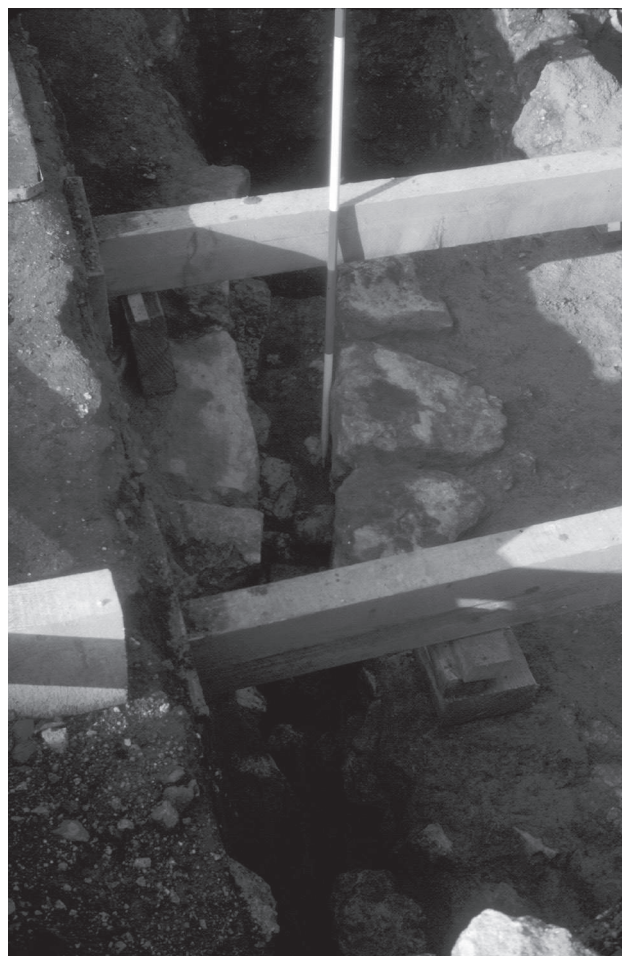
Fig. 6.53. Stone-lined drain cgB11 adjacent to the north–south street: Trench B, LUB 31. Looking north.

Cutting the mid Roman surfaces in the west part of the road (Trench A) was a possible drain cgA3, succeeded by a wooden water-pipe cgA91 (LUB 6; evidenced only by its iron collars) and in the eastern part (Trench B) was a stone-lined drain cgB11 (LUB 31; Fig. 6.53). Sealing the water-pipe was a stone surface cgA92 (LUB 6), and sealing the construction of the stone-lined drain was a stone/gravel surface cgB88 (LUB 31), in turn sealed by a further gravel

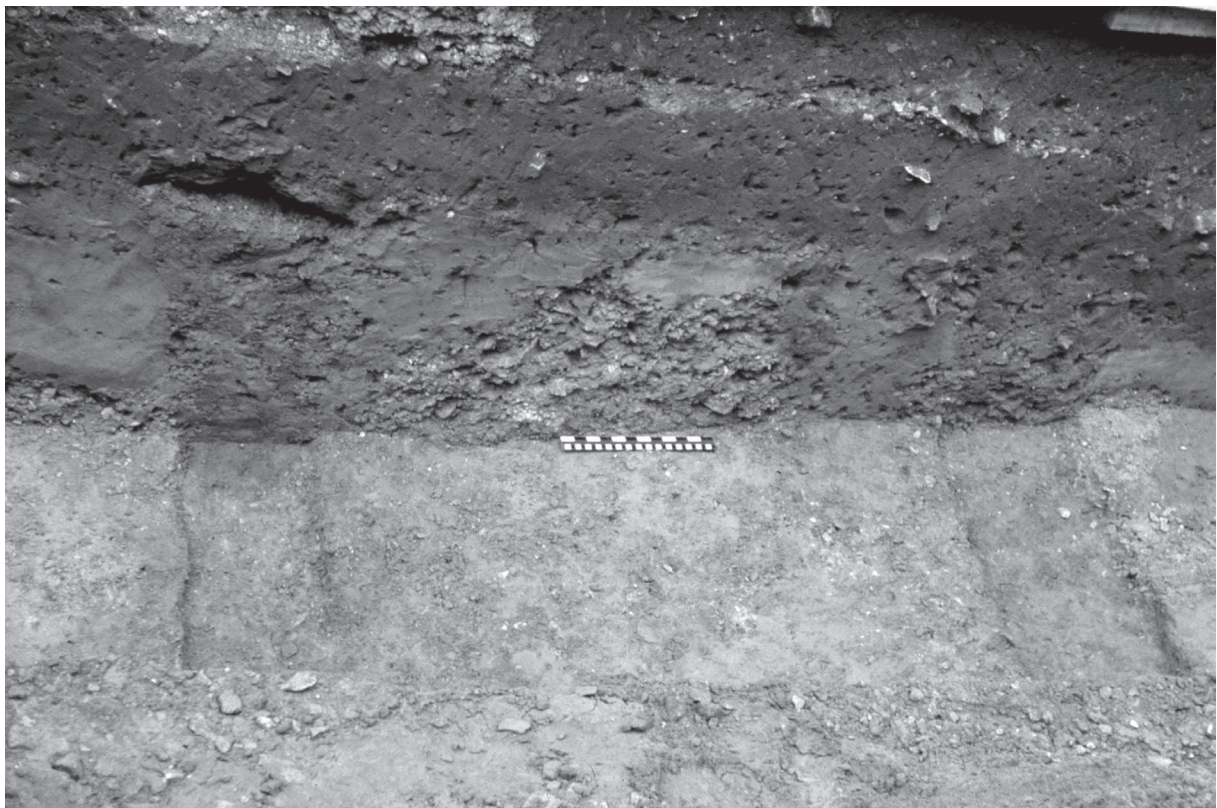
Fig. 6.54. Looking south at slots cgC74 of Structure 20 beneath the rampart: Trench C, LUB 48.

The earliest buildings so far revealed in the south-eastern quarter of the Roman Lower City were those found beneath the defences in Trench C, Structures 20 (Fig. 6.54), 21 and 22. As noted above, these appear to have been storage buildings, but their dating remains uncertain. If the 2nd-century material found with them was contamination, and one or more of the buildings actually belonged to the period before c AD 75–80, they would have been associated with the legionary occupation. The site did produce a large number of pottery vessels and other artefacts of this early date. Similar concentrations of mid to late 1st-century pottery, some indicating high status, were found at the Broadgate East site (be73, below) and in 2003 during the construction of lift-shafts at the Drill Hall, to the south of this site (Jarvis 2004). Here, a large post-pit and an associated clay floor dated to the mid-late 1st century were excavated. The Drill Hall pottery included types of Mediterranean amphorae normally associated with various wines, with olive oil, and with fish sauce (Precious 2004).

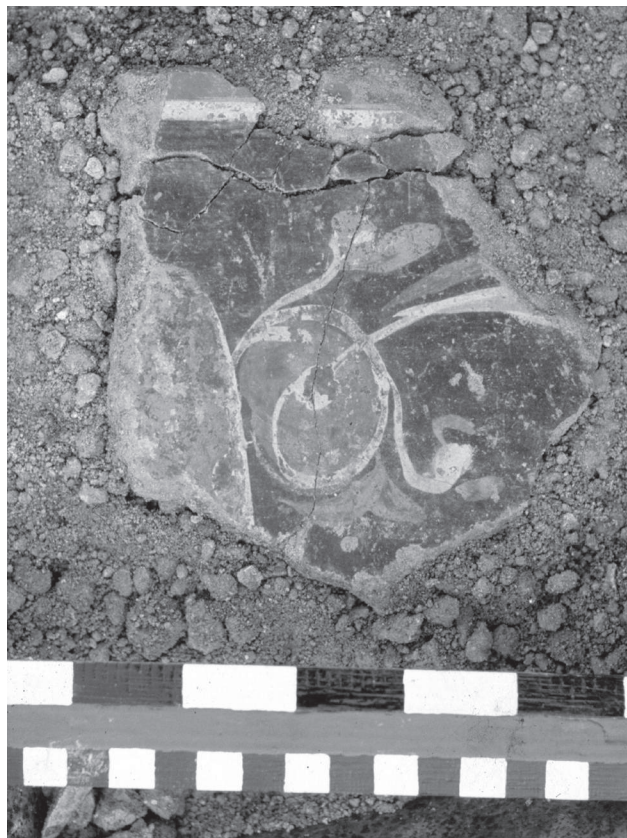
Fig. 6.55. Fragment of painted wall plaster lying in situ within the demolition dump cgC18 immediately beneath the early rampart (LUB 64); possibly derived from Structure 5 (LUB 62) in Trench C.

The interim report on this site (Wacher 1979, 83) suggested that this – at that time including also what is now identified separately here as Structure 3 – had been ‘a house of some substance and elegance’, with ‘décor of high quality’. Much painted wall plaster, most likely from the underlying stone building (Structure 5), had been incorporated into the earliest rampart (LUB 64; Fig 6.55). A relatively large number of the fragments were found to join and they were restored and subsequently published (Davey and

Ling 1982, 133–6, no. 25). The joins suggested that the plaster had not been moved far from its origin and was likely to represent a dump of primary rubbish rather than redeposited material; this would corroborate the idea that it came directly from the demolition of Structure 5. At the Drill Hall in 2003, an early stone building c 35m to the south of Structure 5 produced more wall plaster (Mann 2004, 23). Gold leaf was found on at least one fragment from Silver Street (visually identified; unfortunately, the plaster is now missing); its use in wall painting is very rare (Davey and Ling 1982, 62) and gives some indication of the quality of the building’s decoration.

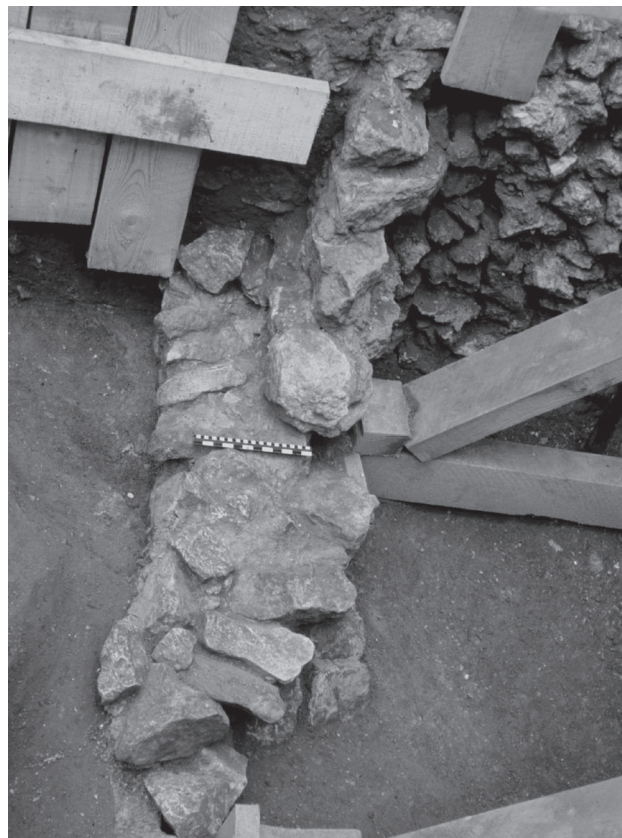
Fig. 6.56. The partly robbed foundations and (in north section) rear face of the thickened Roman city wall cgC31, cut into the earlier rampart: Trench C, LUB 69.

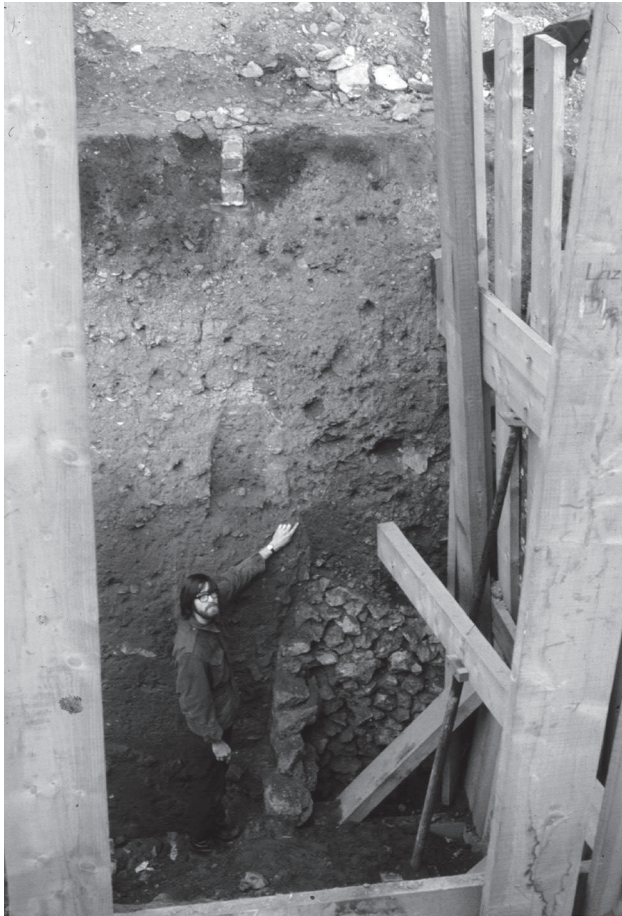
Fig. 6.57. Robber trench cgC104 of the Roman city wall indicated in the north section, cutting through construction trench cgC50 (masked by figure), and rampart (to left of and above figure; cf Fig 6.56): Trench C, LUBs 69 and 87.

Cutting pit cgC49 (LUB 86) was the robber trench cgC104 of the city wall cgC31 (LUB 69; Fig. 6.57). It contained a mixed group of 210 sherds of post-Roman pottery; the latest types belonged to the 19th century.

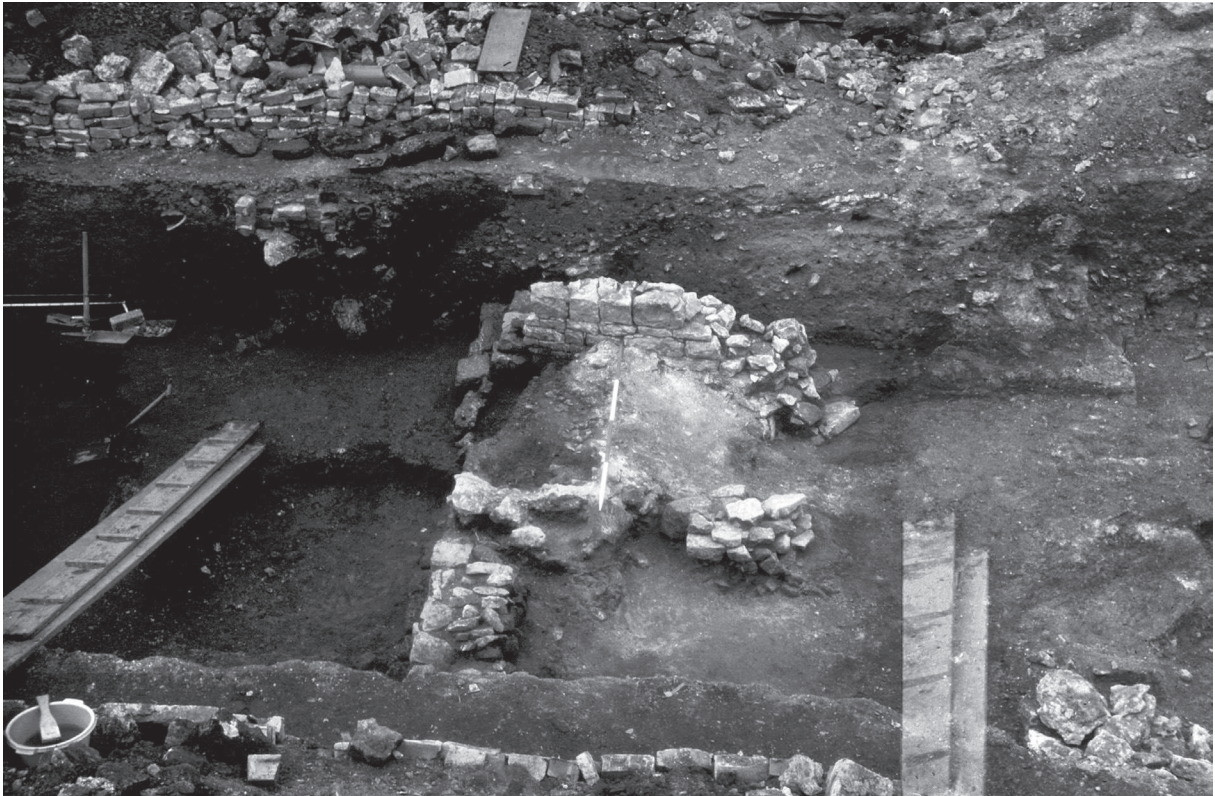
Fig. 6.58. Walls cgC46 and cgC47 of Structure 11, possibly part of the friary precinct wall: Trench C, LUB 81. Looking north.

Added to or inserted into wall cgC46 (LUB 80) were two short east-west flanking walls cgC47, Structure 11 (Fig. 6.58). The foundations (up to 0.75m wide) were bonded with sandy mortar and the upper course consisted of larger, squarer blocks. The two walls appeared to curve as if to form an apse, but there was no evidence that they actually met; if they had they might possibly have indicated a tower projecting out to the east from the north-south wall. It is also possible that they represented a secondary phase of the postulated entrance in the wall initially created in LUB 80. Presumably this was a feature associated with the friary, although it could not itself be closely dated. Two Late Saxon sherds came from foundations cgC47.

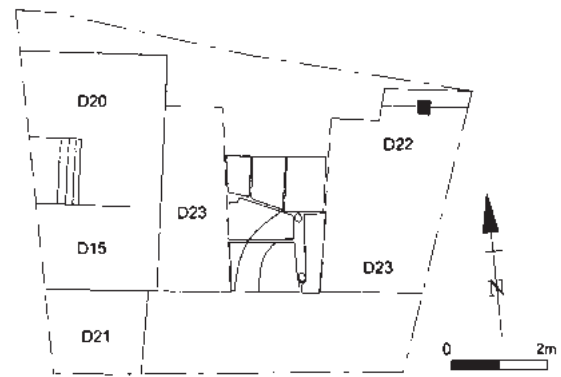
Fig. 7.8. Trench DIV; detailed plan of the postern gate cgD23 in relation to original (cgD15) and rebuilt city wall cgD22 and internal tower cgD20: LUBs 3, 4, 5, 6 and 7

LUB 4 Internal tower (Figs 7.7–8, 7.31, 7.39 and 7.40) Abutting the internal (north) face of wall cgD15 (LUB 3) was a rectangular stone tower cgD20 (Fig. 7.40). The

north wall of the tower was 1.45m thick; what survived of the west and east walls appeared to be of this same dimension, giving an internal measurement for the tower of 1.97m north–south and 5.25m east–west; its external length (east–west) was probably 7.15m. The east wall stepped in with three narrow offsets (each about 0.1m wide). A putlog hole was noted in the internal face of the north wall. No relationship to the rampart cgD12 (LUB 6) survived, owing to later disturbances. There was no dating evidence, but the tower was probably one of a series of ‘interval’ towers around the circuit (as found also in the Upper City and at The Park on the lower western side: see pp. 231, 476), and pre-dated the gateway (LUB 7).

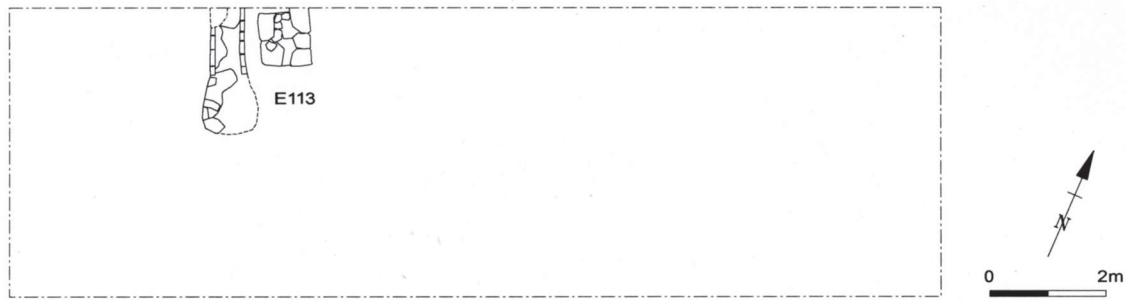
Fig. 7.25. Trench EI; lime kiln cgE113: LUB 69.

LUB 69 Lime kiln (Fig. 7.25)

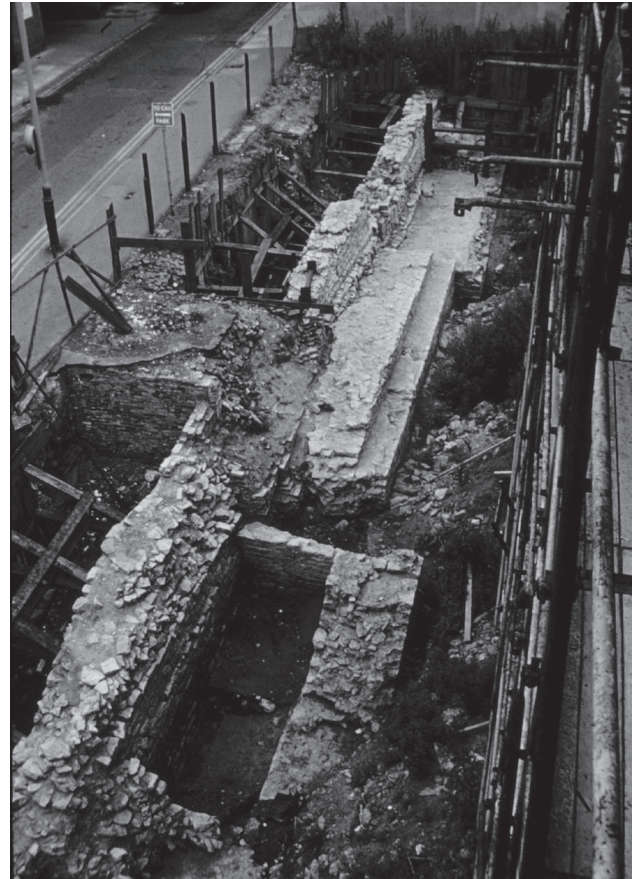
Fig. 7.40. General view of the western part of Trench D, looking west, showing the internal gate-tower cgD20 (foreground), the thickening of the city wall cgD18/19, and medieval stone wall cgD26 above the earlier Roman city wall: Trench D, LUBs 4, 7, and 23.

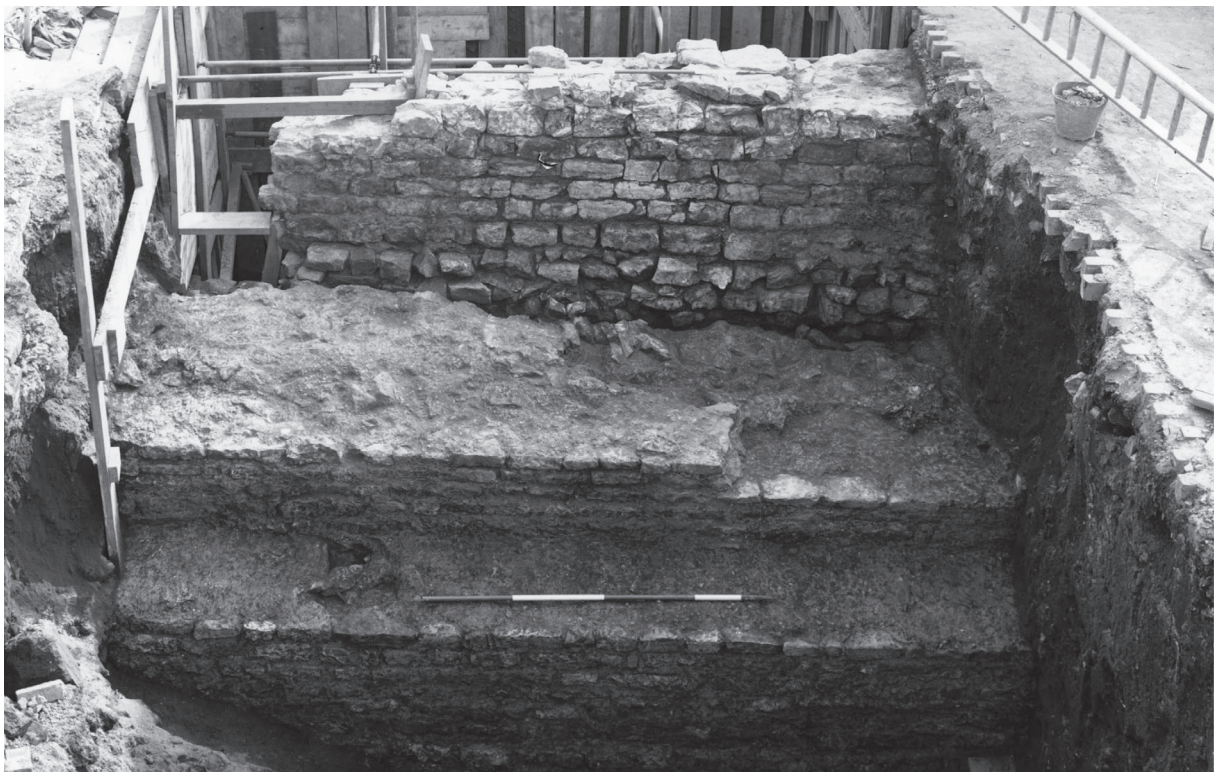
Fig. 7.41. Detail of the internal thickening of the Roman city wall cgD18, with the medieval wall cgD26 above: Trench DIV, LUBs 7 and 23. Looking south.

A robber trench cgD51 was cut from layers above LUB 21 in order to remove stone from the rear part of the Roman city wall cgD18 (LUB 7). It may have been at this time that a narrow medieval wall cgD26 was erected, replacing the Roman wall along its original line, but much less substantial in build and only c 1m wide (Figs 7.40–41). Wall cgD26 probably incorporated reused Roman stone. In the wall was an opening, possibly for a window, suggesting that

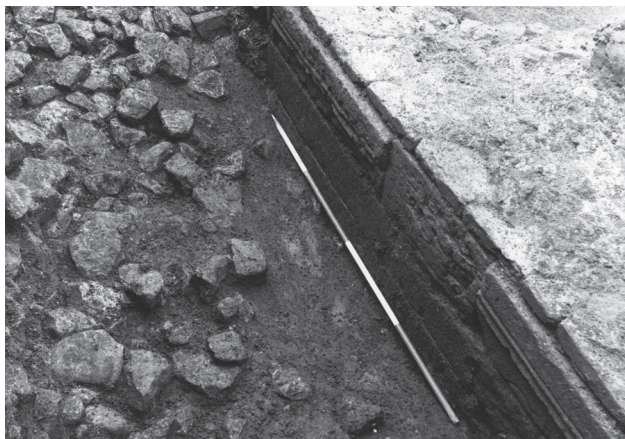
Fig. 7.42. Some of the reused moulded and inscribed stones used in the front face of the rebuilt wall east of the postern gate (cf Fig. 7.43): Trench DIV, LUB 7. Looking north-west.

et al 1975, 284–5; Tomlin *et al* 2009, 175–6). The five inscribed blocks that were revealed had all been used in an inverted position, some along the front face of the gate, and only the bottoms of the large letters, perhaps originally *c* 0.25m high and filled with bronze, survived above a simple moulding (Figs 7.42–44). These appeared to indicate the letters 'NUS', 'LL.DEL', 'IIC' or 'INC', and 'RESPRO' on separate stones. Mark Hassall (*loc cit*) and Birgitta Hoffman (1997) have both suggested that one of the inscribed words – from the last-mentioned stones – may have been 'PROVINCIA', but this is not certain, and it is impossible to reconstruct the original text without the evidence of more elements. It has been estimated, however, that the inscription was originally more than 3m long and more than 1.75m high; the best parallel for this would be a monumental dedication slab from the architrave of a highly significant building. The robbing of such iconic civic buildings in the late Roman period must be recognised as a highly symbolic act in terms of

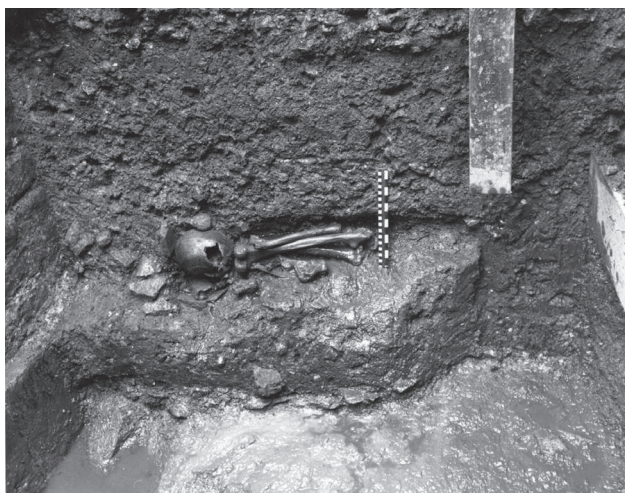
Fig. 7.45. Looking east at the disarticulated skeleton cgD76 found in deposits to the south of the city wall, which can be seen here to the extreme left: Trench DII, LUB 12.

In Trench DII the probable silt layer cgD74 (LUB 9), to the south of the wall cgD15 (LUB 3), was overlain by a thick black/grey deposit cgD75 (about 0.6m thick) containing fragments of greenish decayed limestone. These may have represented a combination of dumping and post-Roman river deposits which built up against the Roman wall, given that layer cgD75 appeared to 'lap' against the wall cgD15 (LUB 3). Sealing layer cgD75 were the disarticulated remains of a young adult cgD76 (Fig. 7.45), identified as probably male (Boylston and Roberts 1995a). These deposits were recorded in section only. Rubble cgD77, possibly tumble from the wall cgD15 (LUB 3), also sealed layer cgD75. A thick compact layer of light brown gravel cgD78 (0.5m thick) sealed both rubble cgD77 and the human remains cgD76. The circumstances of the 'burial' are a matter for conjecture (see p. 232).

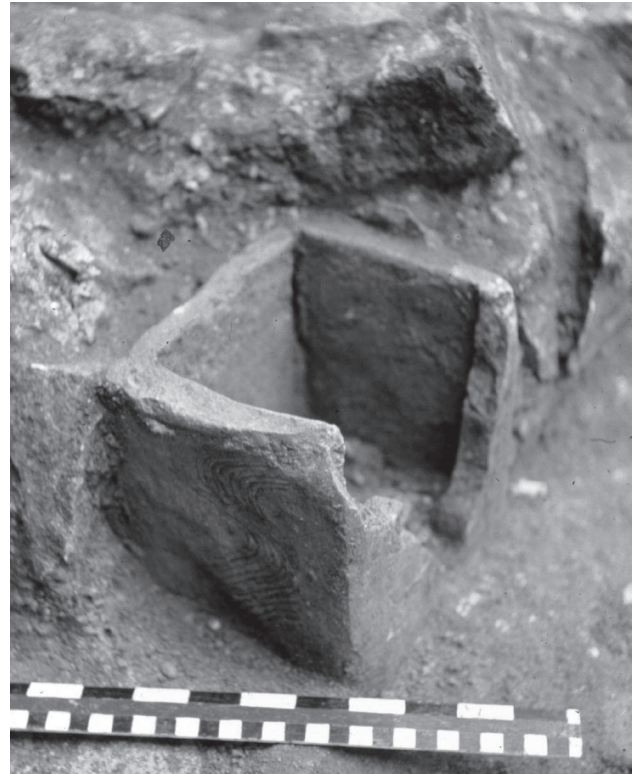
Fig. 7.46. Box-tile flue in situ in Structure 5, room A: Trench EI, LUB 32.

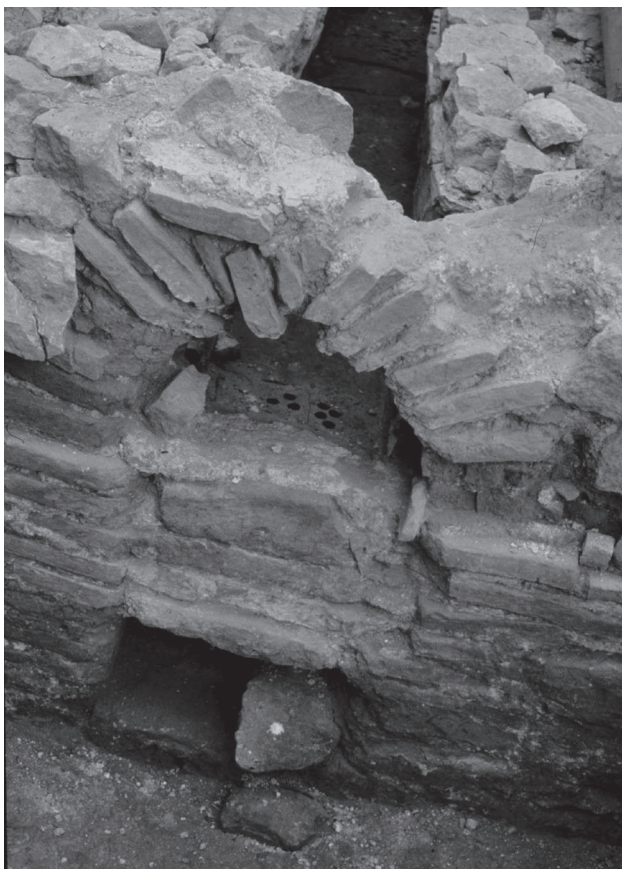
Fig. 7.49. Blocking cgE20 of the hypocaust flue: Trench EI, LUB 48. Looking north.

Cutting through layer cgE22 (**LUB 39**) in Trench EI, sealing the channels cgE129 (**LUB 34**) and E130 (**LUB 35**), and blocking the hypocaust flue-arch in the south wall cgE3 (**LUB 34**), were carefully inserted stones cgE20 (Fig. 7.49). This blocking meant that in its latest phase of use room B was not heated by the hypocaust. There was no dating evidence.

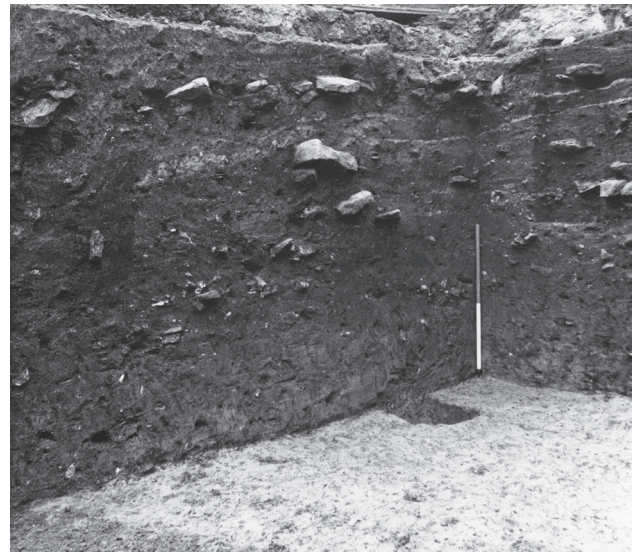
Fig. 7.50. Looking north-west at late to very late Roman post-pit cgF25 cutting clay layers cgF2 in the north-western corner of Trench F.

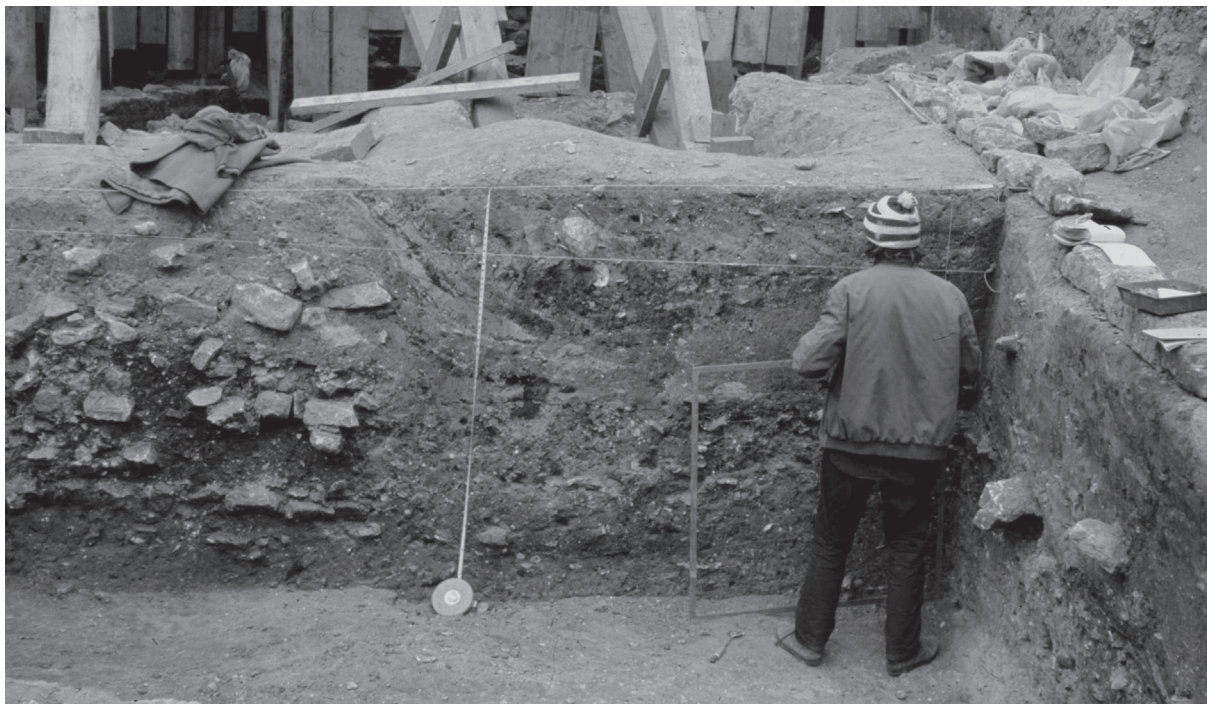
Fig. 7.51. Recording in progress at the north-eastern corner of Trench EII, looking north. Visible are demolition deposit cgE308 of the late Roman building Structure 5 (bottom left), and Late Saxon pit cgE317 (centre): LUBs 51 and 58.

In Trench EII, wall cgE302 (**LUB 45**) was demolished to the level of cgE306 (**LUB 47**) and the remains of the footings were sealed by mortar and rubble cgE308 (Fig. 7.51).

Cutting cgE315 (LUB 56) in the northern part of Trench EII, to the south of Structure 7, was a pit cgE317 (measuring 1.1m east west and over 1.2m north-south; Fig. 7.51). Sealing cgE315 (LUB 56) was an ashy layer cgE318. The pottery (51 post-Roman sherds) from cgE317 included a small group of mid 10th-century sherds, together with four late 10th- or 11th-century sherds that may have been intrusive.

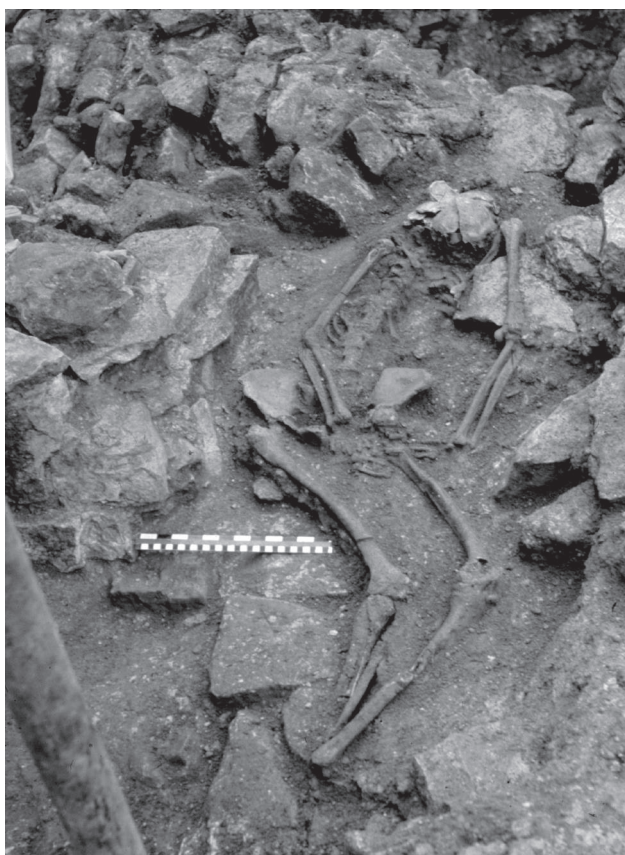
Fig. 7.52. Burial cgE123 cutting through the line of the wall of the Roman house: Trench EI, LUB 52. Looking west.

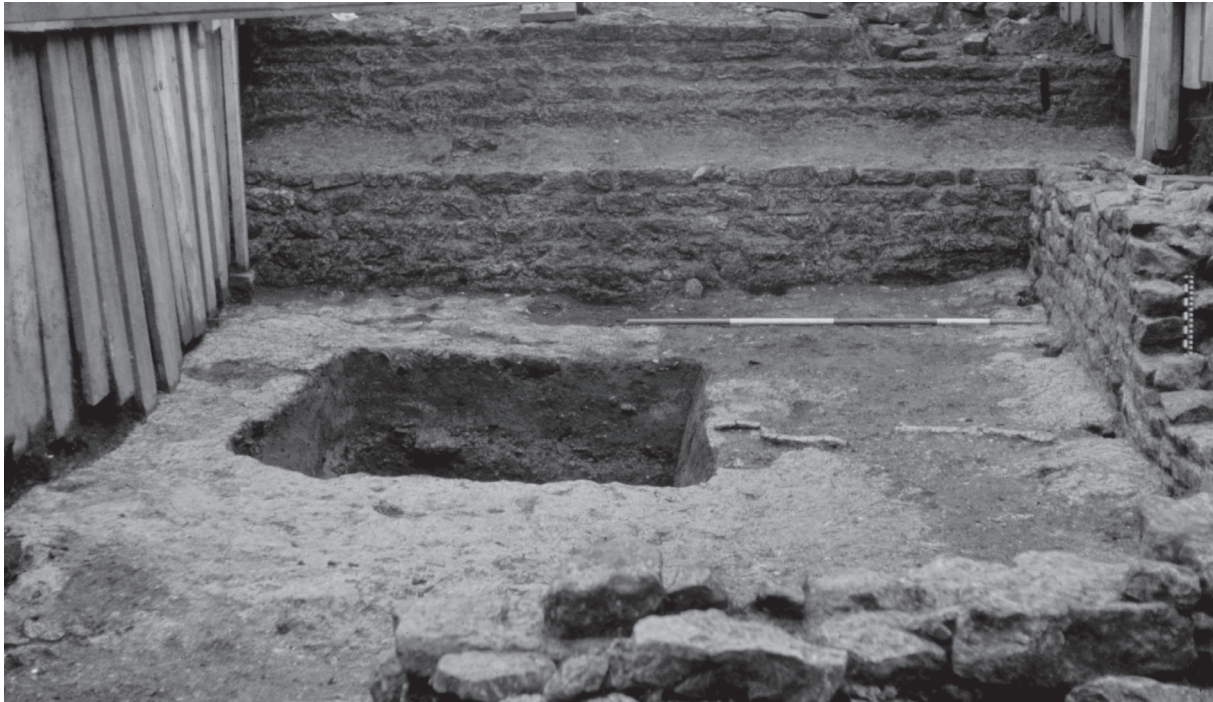
Fig. 7.53. Looking south at the sunken-floored building Structure 2 against the north face of the Roman city wall: Trench DI, LUB 19; note postholes against its west wall.

Structure 2 (LUB 19), a later building located in the same trench, was cut through the Roman rampart and constructed up against the Roman city wall (Fig. 7.53). The Roman rampart had been cut away and on

both sides lined with clay-bonded stone. The floor of the building was of white clay. Pottery dating to the late 9th or 10th century was associated with its construction. The entrance to this sunken room was to the north. The general construction of Structure 2 is similar to that found at St Paul-in-the-Bail (Steane *et al* 2006, 163–5: sp72 LUBs 45–8; Stocker (ed) 2003, 258), initially built in the late 10th century and partially rebuilt in the 11th century.

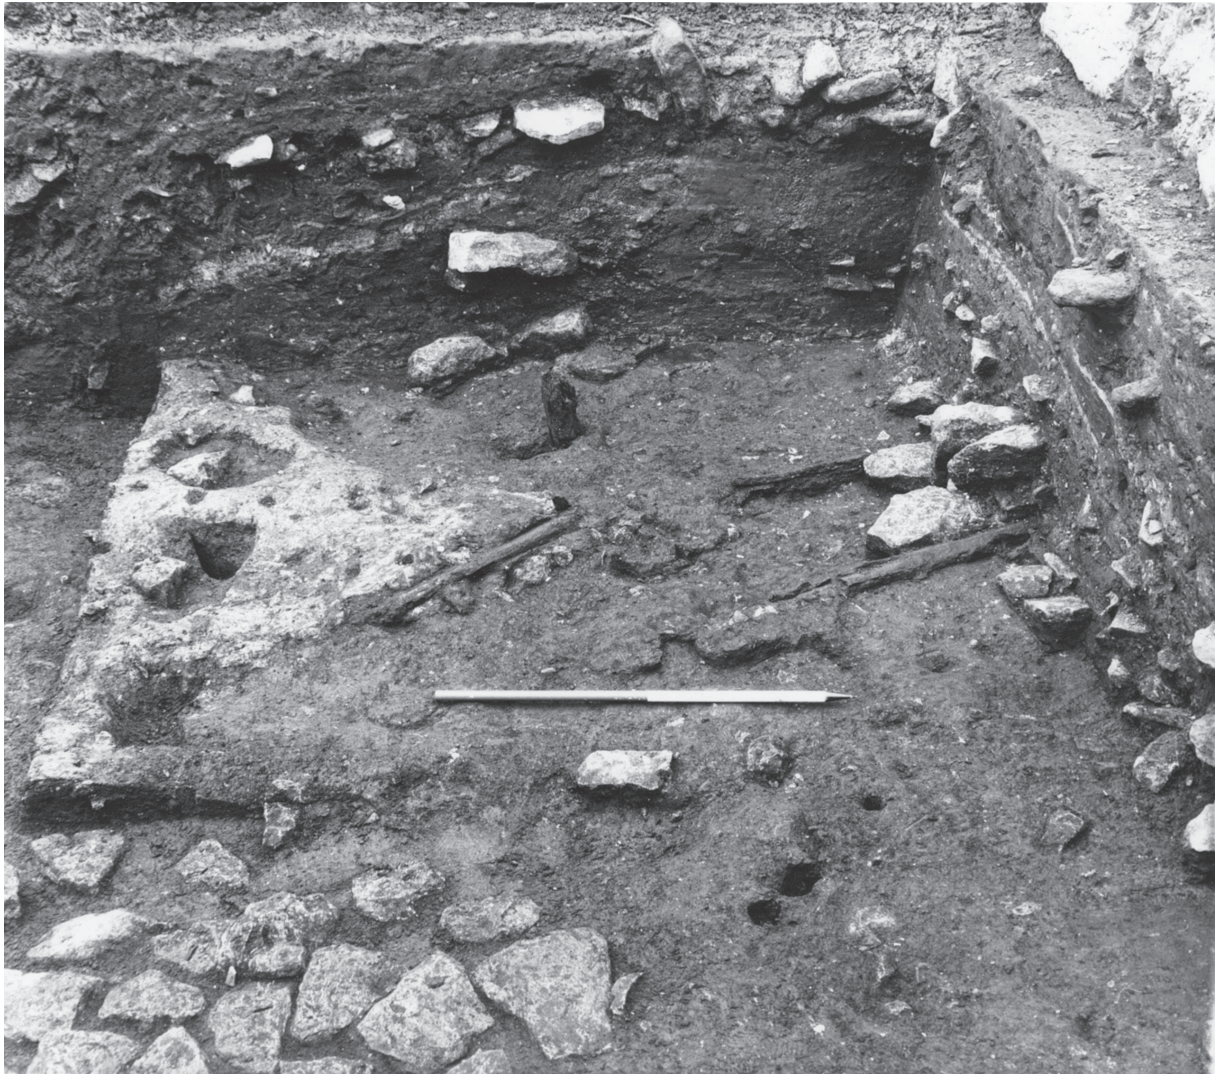
Fig. 7.54. Looking west at various Late Saxon features in Trench F, including clay floor (left), wooden drain (right), and stones which may have served as a sill. Vertical posts of timber structures also visible.

In Trench F there was clear evidence for a line of posts, as well as several lines of stake-holes. However, it is not clear how these related to each other, except that there was evidence here for at least one earth-fast building (Fig. 7.54), and possibly later timber-framed buildings. The pottery from this trench dated from the late 9th or early 10th century through to the early-mid 11th century, indicating continuous occupation throughout this period.

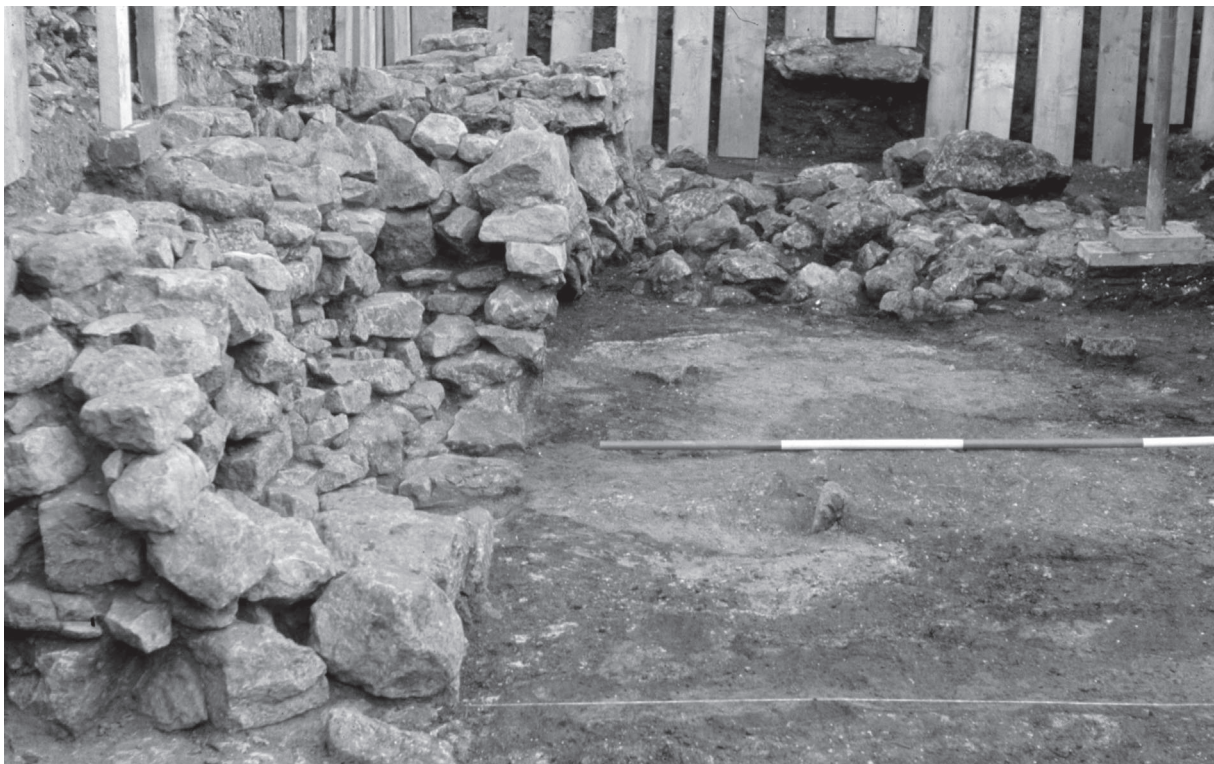
Fig. 7.56. Looking east at the substantial foundations cgE84 of the medieval building, Structure 9, along the north section of Trench EI: LUB 65.

1945, 157), but we cannot be sure if this referred to the present site. In Trench EI was the substantial south wall and buttress of Structure 9 (LUB 65; Fig. 7.56). The actual date of the construction of this building is unclear but it seems likely that it was built in the early medieval period. The foundations were about 1.8m deep, suggesting that the wall supported a high structure. Amongst the small quantity of post-Roman tile that was not discarded were a number of early glazed flat roof-tiles (of mid 12th- to early/mid 13th-century date), several glazed

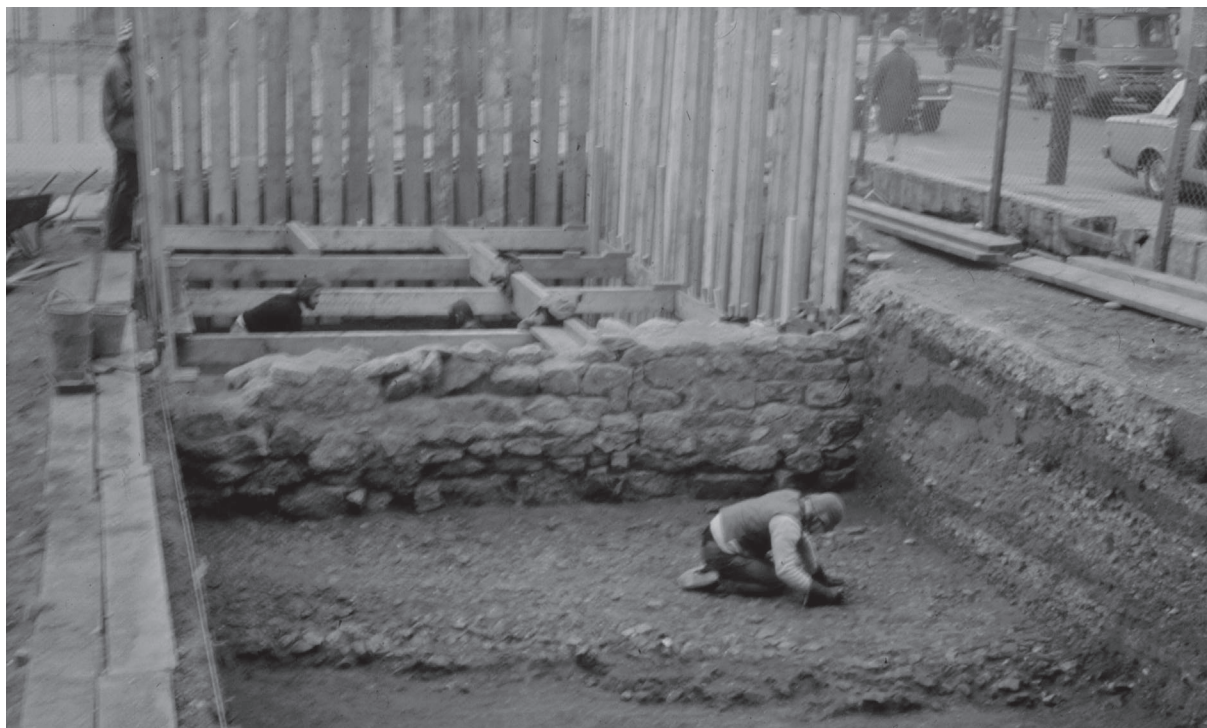
Fig. 7.57. Looking west at post-medieval lane cgE110/140 and adjacent stone wall cgE136 running towards Silver Street (right): Trench EI, LUBs 72 and 75.

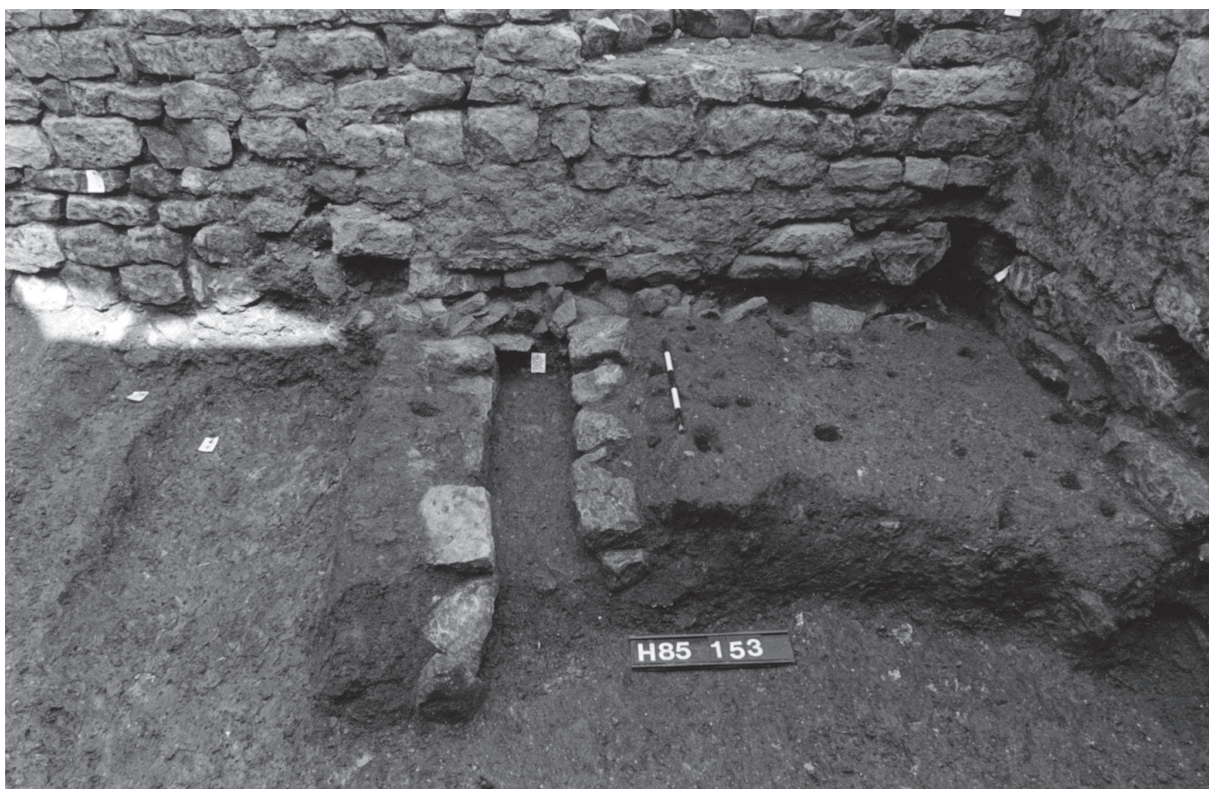
Fig. 8.45. Looking north at drain cg28, cut by the foundations of wall cg76: LUBs 4 and 5.

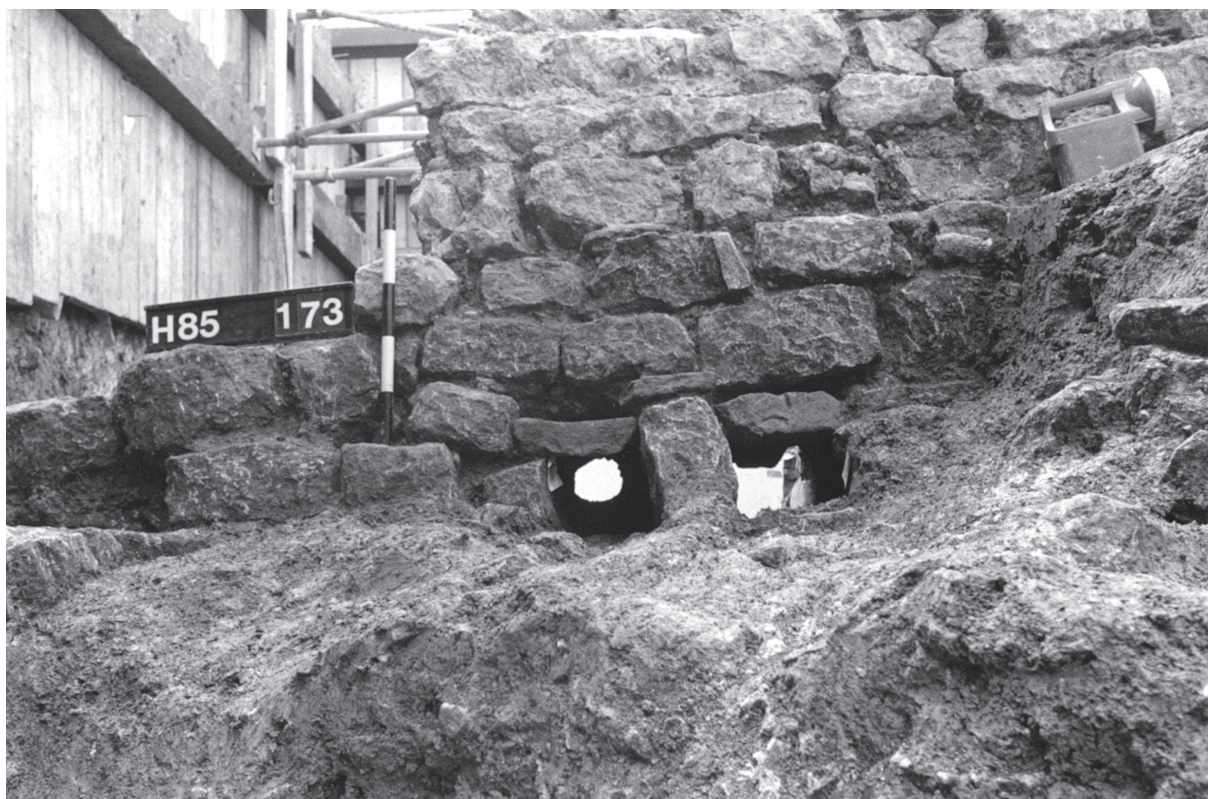
Fig. 8.47. Looking west at the partially excavated wall cg76 incorporating two water-pipes cg57: LUB 5; the circular shape of an iron collar can be seen in the left hand opening.

Running east–west through the east wall of room 2B were two water-pipes cg57 (Fig. 8.47). The presence of the pipes was recognised partly from their iron collars surviving in the lower part of the wall cg76. One of these was complete (1409) <1790> and fragments of at least one other collar (1402) <1758–60> were also recovered. The pipes probably ran continuously all the way into the east section of the trench, but this course was also crossed by another feature that appeared to be integral to the construction of Structure 2: the south wall of 2C appeared to incorporate from the start a stone-lined culvert cg536, 0.3m wide and 0.9m deep. It

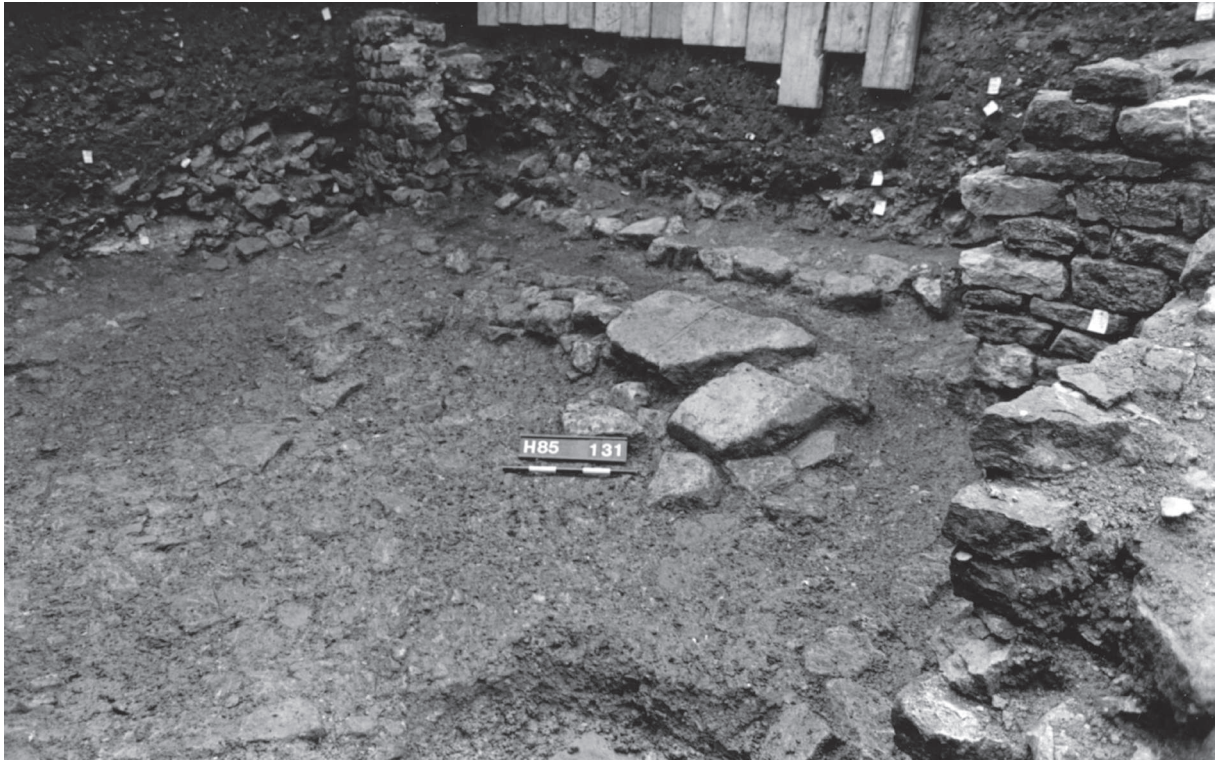
Fig. 8.48. Looking north-west at the wide doorway separating the southern strip of room 2A (in the background, against the trench section) from 2B/2D, with the remains of partly-paved surface cg88 of 2D.1 visible in the foreground: LUBs 5, 6 and 10.

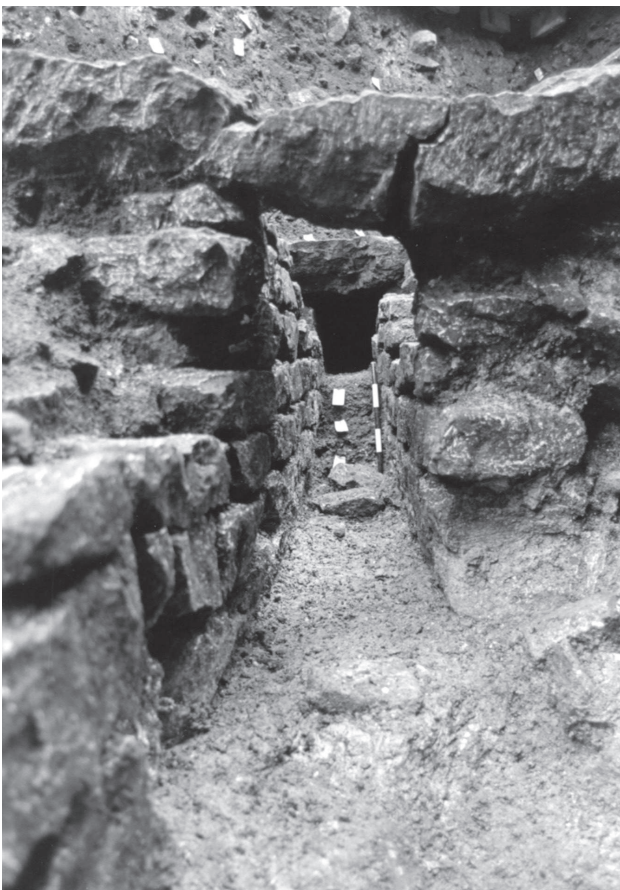
Fig. 8.49. The stone-lined culvert cg536 in 2C: LUB 8. Looking north-east.

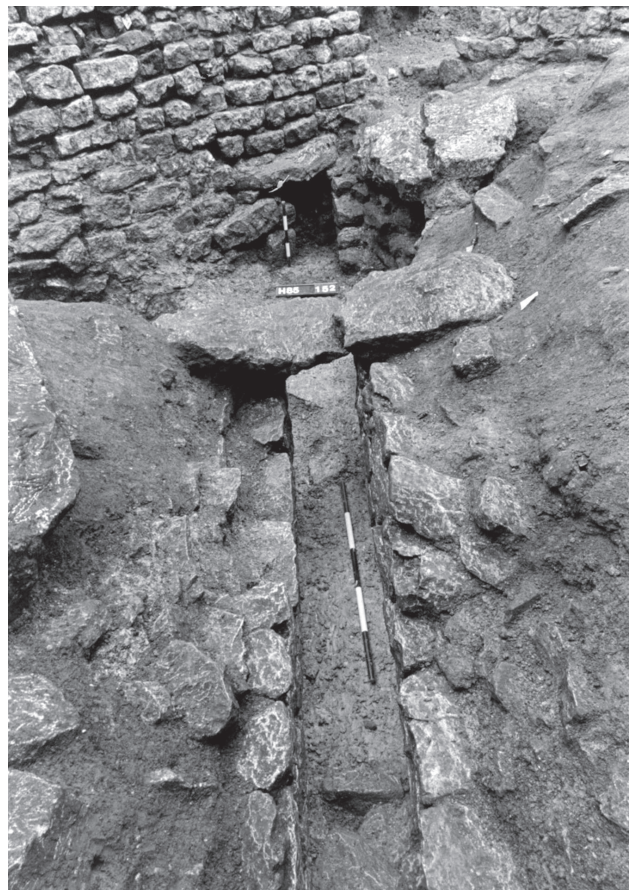
Fig. 8.50. Looking south-west at the stone-lined culvert cg536, integral with the south wall of 2C: LUB 8.

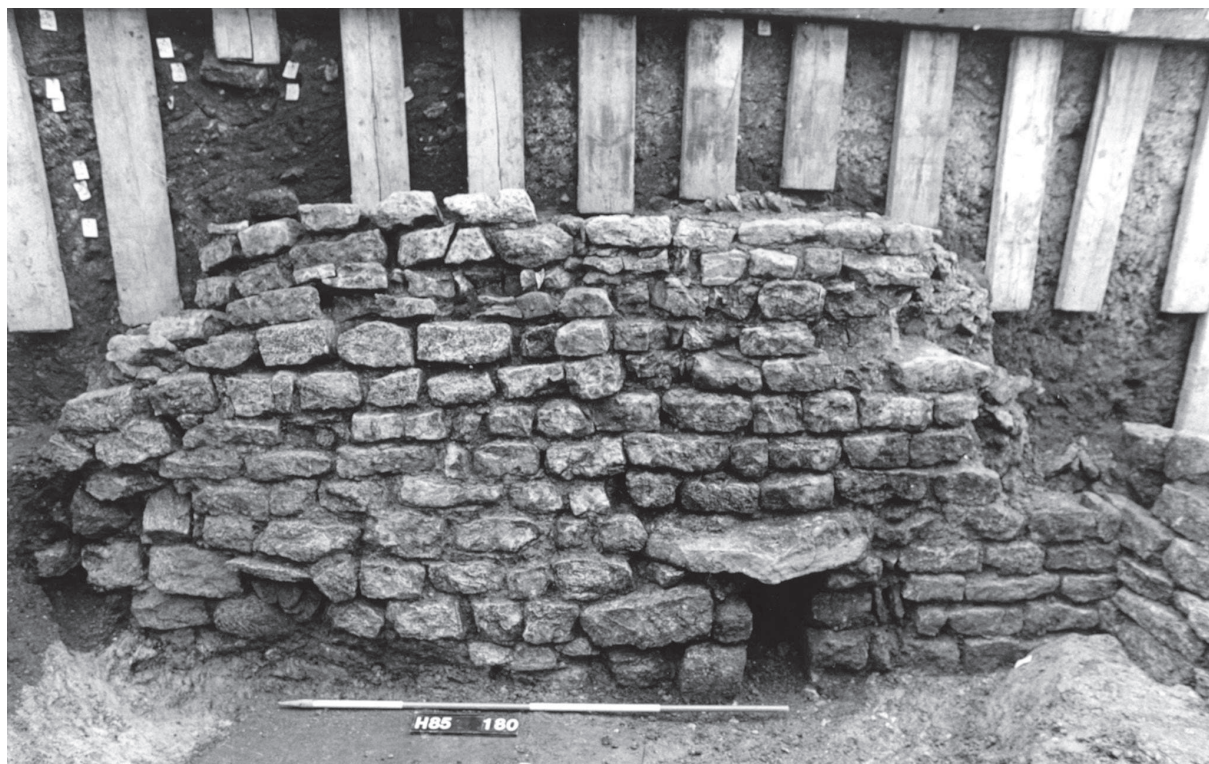
Fig. 8.51. The south wall cg76 of 2C, showing opening for culvert cg536: LUB 8. Looking south.
